MANUFACTURING SAFETY ALERT

Face Laceration / Line of Fire

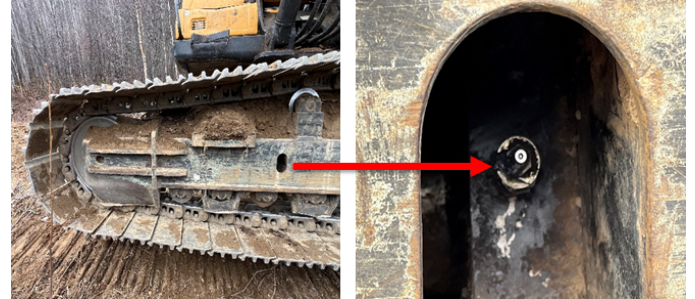
During the replacement of a pinion adjustment cylinder on a track excavator, a mass of pressurized lubricant grease spewed from the nanometer into the worker's face/cheek, who was in the line of fire.

The worker required surgery to remove and clean the grease from inside his face. Unfortunately, the incident resulted in permanent eye damage.

- Share the incident with workers.
- Have the Superintendent and HSE Coordinator meet with contractors to emphasize the importance of evaluating all potential lines of fire during tasks.

Be aware of pressure build up in cylinders.
